**AN INVESTIGATION  
OF ACOUSTIC EMISSION  
FROM DEFECT FORMATION  
IN STAINLESS STEEL WELD COUPONS**

BNWL-902

C. K. Day

January 1969

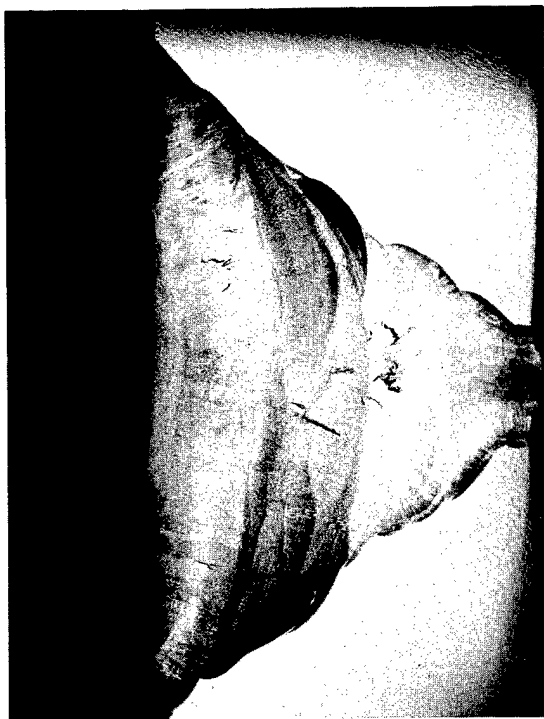
FIGURE 11. *Photomicrographs of Test Welds with Differing Weld Quality*

Typical photomicrographs of the weld region for these samples are shown in Figure 11. The relative crack lengths were 0.52 for Sample 25, 5.4 for Weld 27, and 6.9 for Weld Number 23. As can be seen from the photomicrographs, there is a wide variation in the quality of 27 and 23 but they have

approximately the same crack lengths. This is because of the difficulty associated with determining the actual length of cracks produced by the addition of titanium.

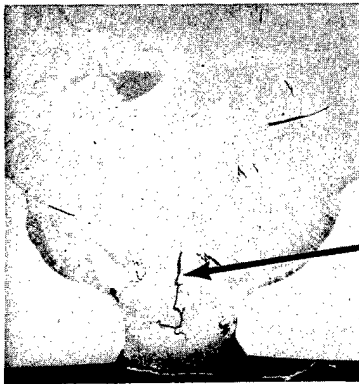
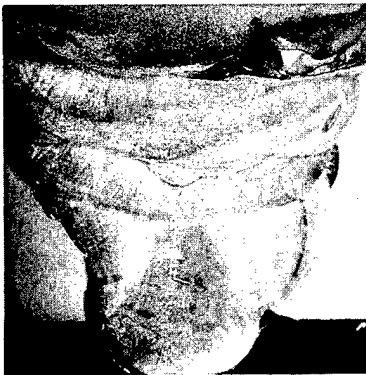
*FIGURE 13. Bottom Region of Weld Samples  
Where Hot Cracks Formed and Were Detected  
Visually During the Welding Operation*

Hot cracks which formed in the bottom region appeared to "flow" apart for some distance following the puddle of filler material as it cooled. During this growing period acoustic emission was not produced, which is contrary to experience with emission from crack growth.<sup>(4)</sup> Figure 12 shows, however, that in general more acoustic emission was obtained from samples where visible cracks were detected during the first passes than for those where cracks were not observed. Figure 13 is made up of photomicrographs of the four welds listed on Figure 12. Each of these welds had hot cracks that were observed during welding, but some were apparently remelted since they are not all detectable in the photomicrographs.

Hot  
Cracks

Hot Cracks  
Apparently  
Remelted

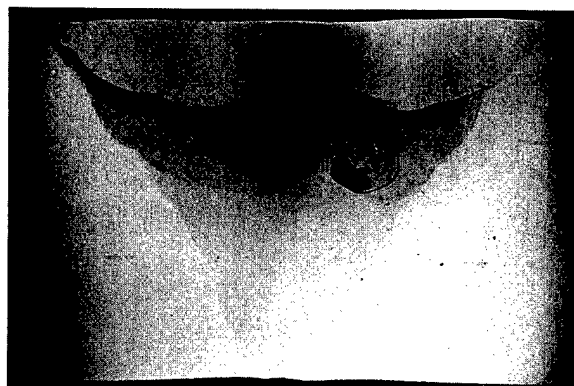
**FIGURE 14.** Test Welds Containing Porosity. (Large Amounts of Acoustic Emission Were Produced by These Welds.)

Crack formation appeared to be the weld defect causing most of the acoustic emission throughout this study. There were, however, indications that gross porosity formation produced some of the emission since high signal levels were obtained from Samples 7, 9, and 20, shown in Figure 14. These samples contain large amounts of porosity as demonstrated by the radiographs and photomicrographs. However, some cracking accompanied the porosity, and this may have been the source of all emission.

A. Test Weld No. 7  
Total Acoustic Emission 426

B. Test Weld No. 9  
Total Acoustic Emission 466

C. Test Weld No. 20  
Total Acoustic Emission 411

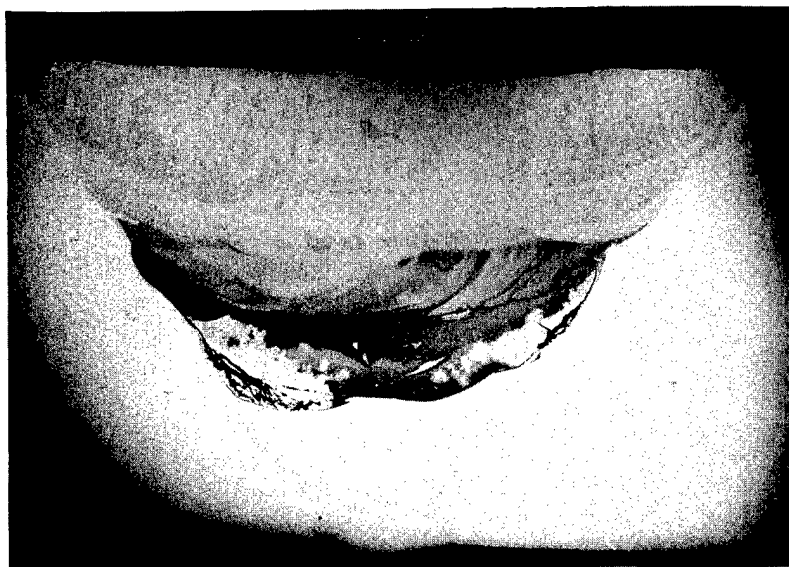
*FIGURE 15. Welds Producing Acoustic Emission from Cracks that Were Not Detected by Conventional Radiographic Techniques.*

All of the defective welds produced acoustic emission in varying degrees. Two cracked welds produced emission but were not considered as having cracks by radiography. These were Samples 11 and 14 shown in Figure 15. Two hundred signals were produced by Sample 11 while Weld 14 was one of the worst

A. Test Weld No. 14  
Total Acoustic Emission 10300

B. Test Weld No. 11  
Total Acoustic Emission 200

produced according to acoustic emission with approximately 10,000 signals observed. Photomicrographs of these samples are shown in Figure 15.
